# Impact of heat on the deterioration of facades of the industrial heritage of the Peruvian Sierra

Research Article

The study area is located on a section of a street in the historic center of Arequipa, Peru, where the facades of the former Museum of Contemporary Art (EM-1 and EM-2) and the Casona del Tranvía (CT-1) are located (Figure 1).

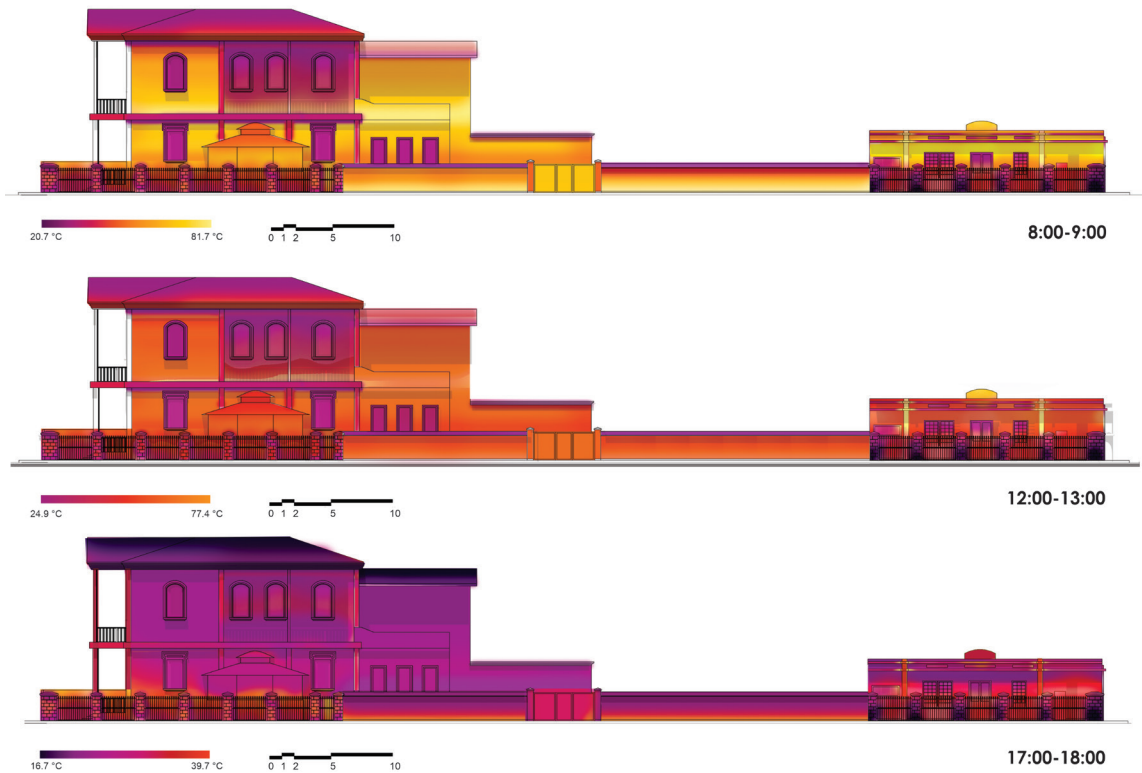
Figure 6: Temperature map of facades. (2024)

For the EM-1 section, the material with the highest heat level is ignimbrite, which makes up the entirety of its walls, followed by the stone found in columns C1, C2, C3, and C4.

On the other hand, on the EM-2 section, PA1 recorded the highest temperature in the morning, at  $81.7^\circ$ , reaffirming the signs of structural damage previously identified. The rest of the materials maintained an average temperature ranging from  $30$  to  $50^\circ\text{C}$ .

In the afternoon, although the maximum temperature on both facades dropped by 3°C, the temperature of the concrete, steel, stone, and pavement rose, exceeding 70°C (Figure 7). The temperature of the ignimbrite material on the EM-2 facade rose by 30°C. This significant increase may be related to the low traffic volume in that area.

The high temperatures observed in the steel correspond to the columns of CT1, differing from the steel in the perimeter enclosures, where wind flow causes temperatures to decrease in that area, making it less uncomfortable to walk along those facades. Furthermore, the average temperature ranges from 40–70°C, intensifying the heat sensation on the facades.

On the other hand, at night, temperatures drop to as low as 40°C. Furthermore, it was observed that the materials that stored the most heat were the ignimbrite and the pavement on the EM-1 and EM-2 facades, which also show the most signs of spalling.

The dirt accumulated on the capitals of the pillars, as well as on parts of the walls and the ignimbrite ornamentation, indicates higher detected temperature levels, causing greater damage to the infrastructure.

Door PA1, which shows greater wear in the lower area, is associated with the high temperature detected at the horizontal level, as well as its proximity to the pavement, which also maintains a constant heat level.

Elements painted in dark tones compromise the integrity of the large houses, as they cause temperature variations on any material, such as the columns and ornamentation of CT1 and EM1, as well as on the pillars.
