Advanced photogrammetric techniques for heritage conservation: a case study of the visual and architectural preservation of the Jagannath Temple, Puri Técnicas fotogramétricas avanzadas para la conservación del patrimonio: un estudio de caso del Templo de Jagannath, Puri

AMIT CHATTERJEE

BHARATI MOHAPATRA

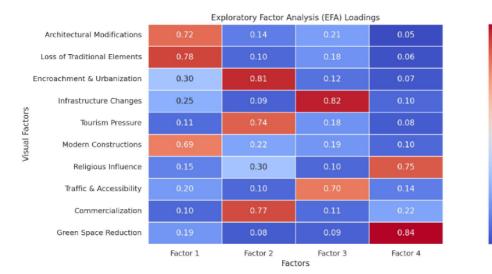
Figure 2: Exploratory Factor Analysis (EFA) Loadings for Visual Factors. (2024)

Principal Axis Factoring was used to analyse the data and Varimax rotation was used to extract the latent factors. Bartlett's Test of Sphericity and the Kaiser-Meyer-Olkin (KMO) measure were used to determine the appropriateness of the dataset for factor analysis. The EFA results identified four major factors groupings of the 10 visual variables to help structure the understanding of how different aspects transform the temple precinct. Figure 3 Exploratory Factor Analysis (EFA) Loadings for Visual Factors.

Factor 1: Architectural transformations

It captures the major shifts in the traditional architecture that have occurred with modernization and new constructions. The high loadings for this factor are Architectural Modifications (0.72), Traditional Elements Lost (0.78), and Modern Constructions (0.69). This factor focuses on the fact that cultural and architectural heritage is being lost with traditional elements being replaced by modern designs and structures.

Factor 2: Urban encroachment & Tourism impact

This includes the impacts of urbanization and tourism on the built environment. Encroachment & Urbanization has the highest loadings at 0.81, followed by Tourism Pressure at 0.74 and Commercialization at 0.77. These aspects show how increasing tourism and urbanization lead to the commercialization of places, which in turn alters the authenticity of historical and cultural sites.

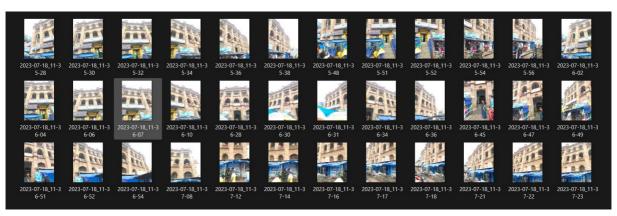
Figure 3: 60% Overlapping of Images. (2024).

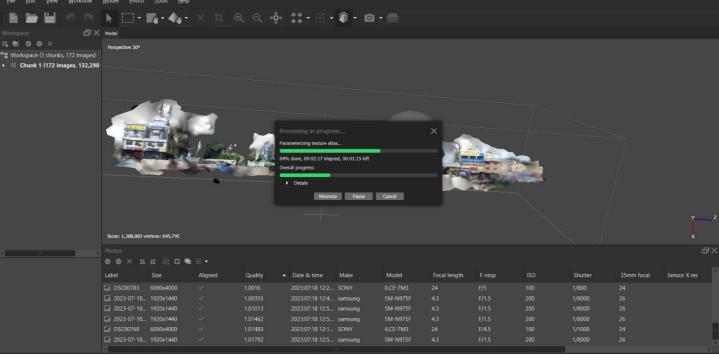
Figure 4: Software Processing Reality Capture and Meta Shape. (2024).

Though there were problems with the amount of data and the complexity of the objects (congested environment and intricate architecture), the photogrammetry software was able to process images (Figure 4).

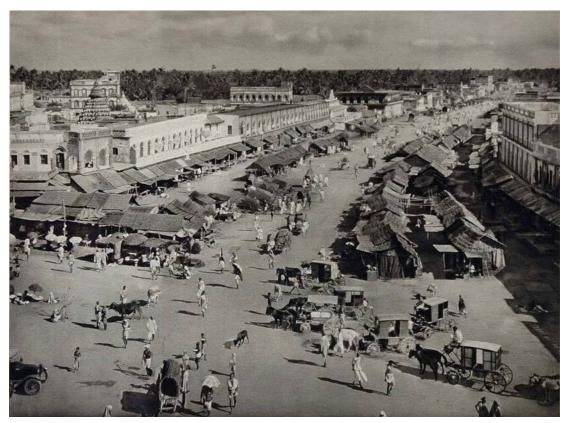
Figure 6: Grand Road, Bada Danda in front of Jagannatha Temple taken in 1928. Talkpundit (2017)

This historical photo of *Bada Danda* taken in 1928 (Figure 6) shows the drastic changes that have taken place between the past and the present. On the one hand, the precinct has been developed to cater for the increasing population as well as the infrastructure in the urban area but, on the other hand, it has also lost its traditional beauty and heritage values. This shift stresses the importance of heritage management to ensure that Puri's historical and cultural significance is maintained, even as the city faces pressures from urbanization. The architectural landscape also features historic buildings

and temple structures, but it also incorporates the marketplace, suggesting a balance between urban activity and religious sanctity.

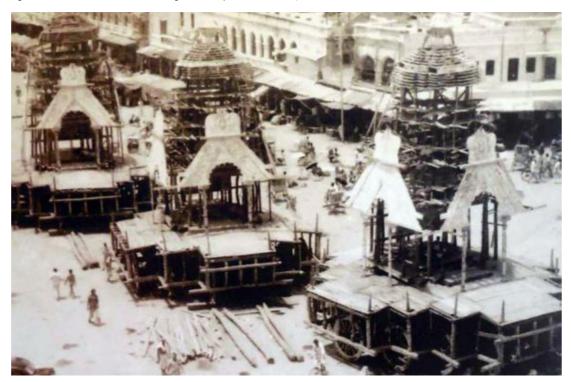
Figure 7: Grand Road, Bada Danda during Rathyatra. Talkpundit (2017).

The buildings in the background of Figure 7 are from the early to mid-20th century and represent the various architectural styles. It has arched openings, decorative cornices and intricate details of colonial era buildings. These structures are the background to the Bada Danda which leads to the Jagannath Temple, an area which in the past was home to commercial shops, pilgrim accommodations and administrative buildings.
